# Coastal erosion in sandy beaches along a tectonically active coast: The Chile study case

Progress in Physical Geography  
2021, Vol. 0(0) 1–22  
© The Author(s) 2021  
Article reuse guidelines:  
[sagepub.com/journals-permissions](https://sagepub.com/journals-permissions)  
DOI: 10.1177/03091333211057194  
[journals.sagepub.com/home/ppg](https://journals.sagepub.com/home/ppg)

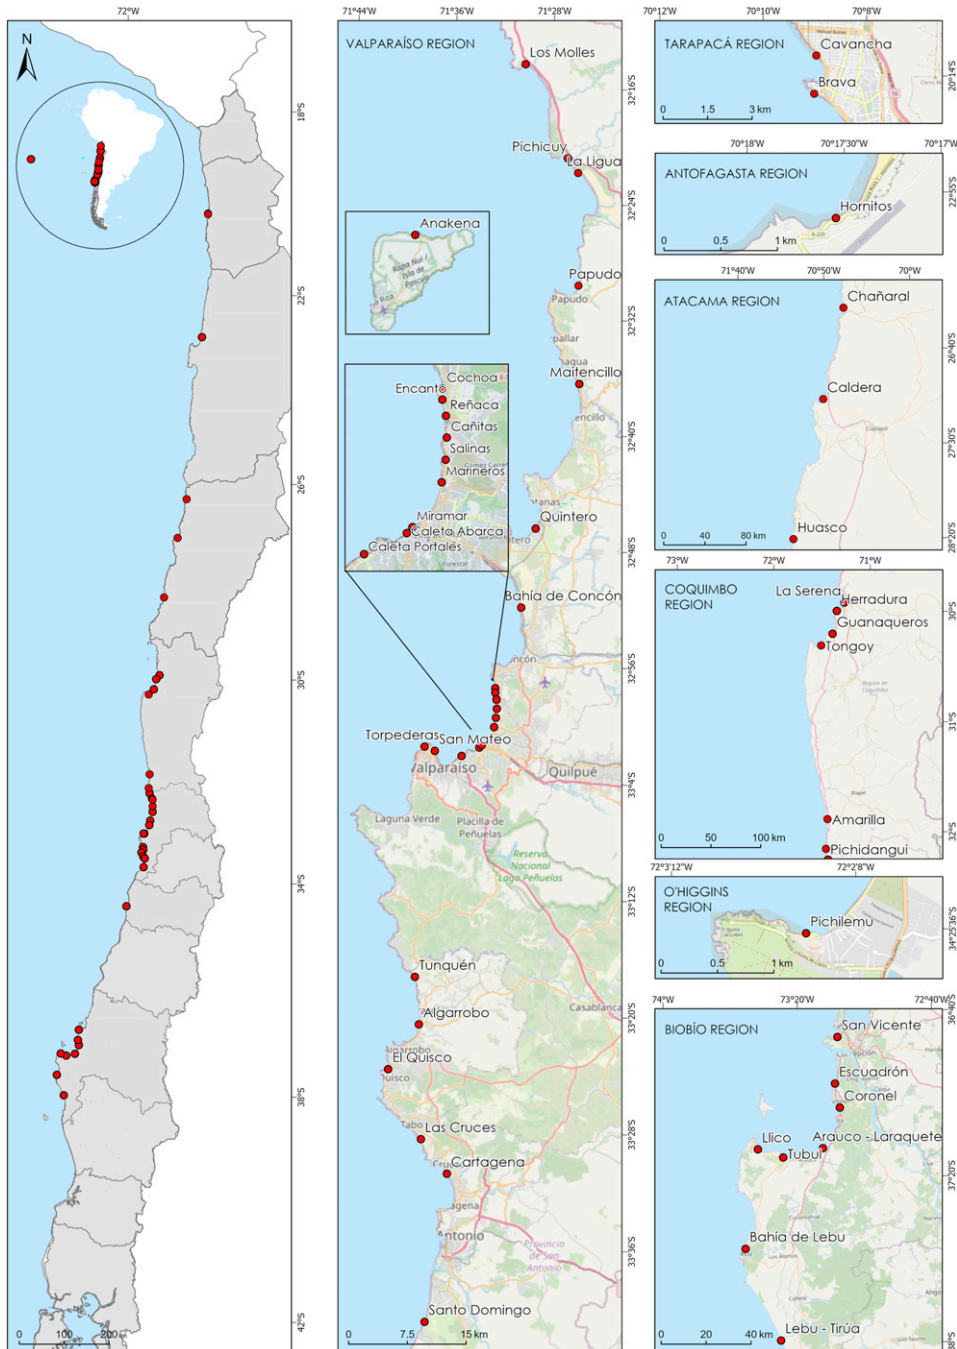
**Figure I.** Geographical context of the 45 beaches under study. For interpretation of the references to colours in this figure legend, refer to the online version of this article.

(Figure 1). Details of the data is included in Table A1. DSAS has been used at regional scale and for long series of time in Colombia (Rangel et al., 2015), Malaysia (Bagheri et al., 2019) and Australia (Konlechner et al., 2020). The annual rates of change in shoreline position were determined through the Linear Regression Rate method (LRR) along several transects within each beach, during winter and spring (Figure 2). Then, the mean rate of change for each beach was then computed as the average of the rates obtained from each profile. The LRR calculates the rate of change by fitting a least squares regression line to all the points in the shoreline for each transect. The method is easy to use and well suited for the amount of beaches and transects under scrutiny.

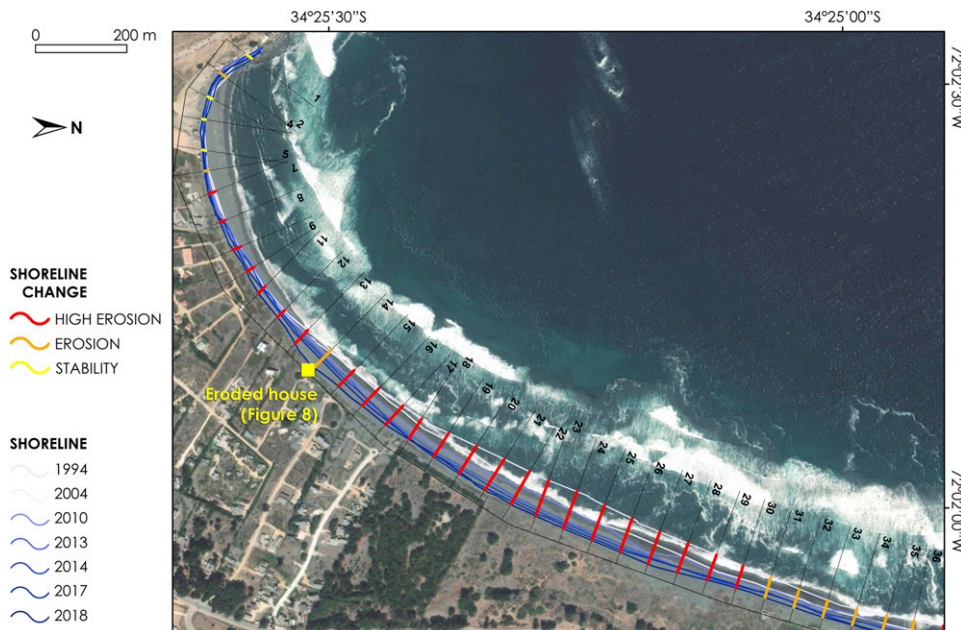
**Figure 2.** Example of application of the Digital Shoreline Analysis System (DSAS) in Pichilemu. The annual shoreline rate of change is classified according to Rangel-Buitrago et al. (2015) categories: high erosion ( $>-1.5$  m/yr), erosion (between  $-0.2$  and  $-1.5$  m/yr), stability (between  $-0.2$  and  $+0.2$  m/yr) and accretion ( $>+0.2$  m/yr). For interpretation of the references to colours in this figure legend, refer to the online version of this article.

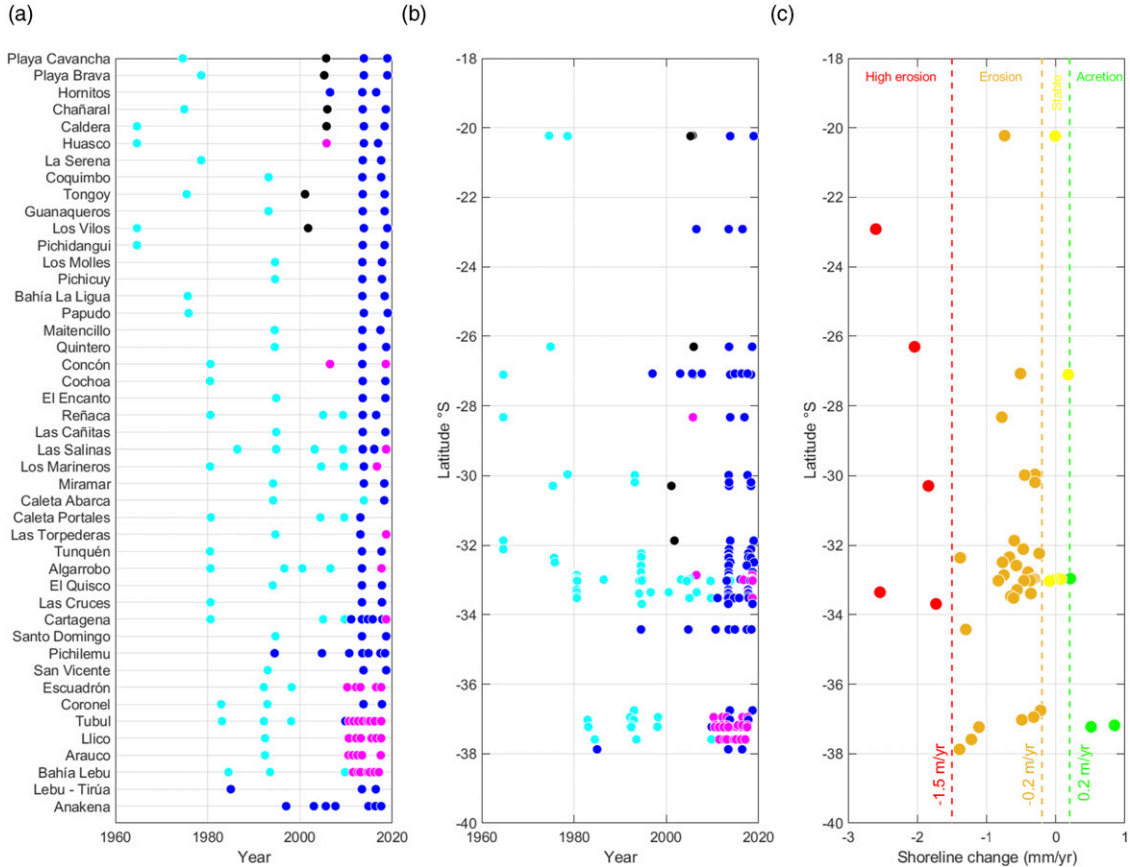
**Figure 3.** (a) Spatial-temporal distribution of topographic surveys (magenta), aerial photographs (cyan), satellite images (blue) and survey maps (black) used in the analysis of the shoreline evolution in 45 beaches. (b) same as (a) but distributed latitudinal. (c) Latitudinal distribution of the annual shoreline rate of change for each beach classified according to [Rangel-Buitrago et al. \(2015\)](#) categories. For interpretation of the references to colours in this figure legend, refer to the online version of this article.

Changes in the shoreline position in 45 beaches were determined from 39 topographic surveys, 63 aerial photographs and 91 satellite images and 6 survey maps ([Figure 3\(a\)](#)). The sampling frequency and periods differ among beaches, the longest period being 54 years between 1964 and 2018 (Caldera, Los Vilos and Pichidangui) and the most recent 2006–2016 (Hornitos). The mean range of analysis was

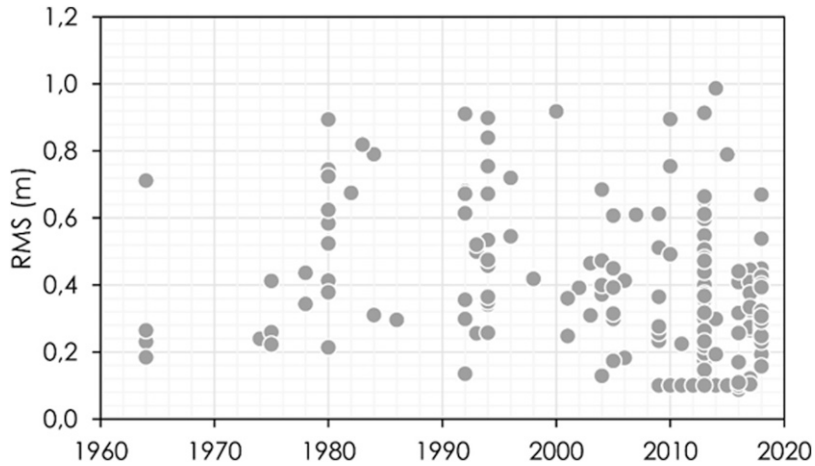
**Figure 4.** RMS error for the 201 aerial photographs and satellite images used in the study.

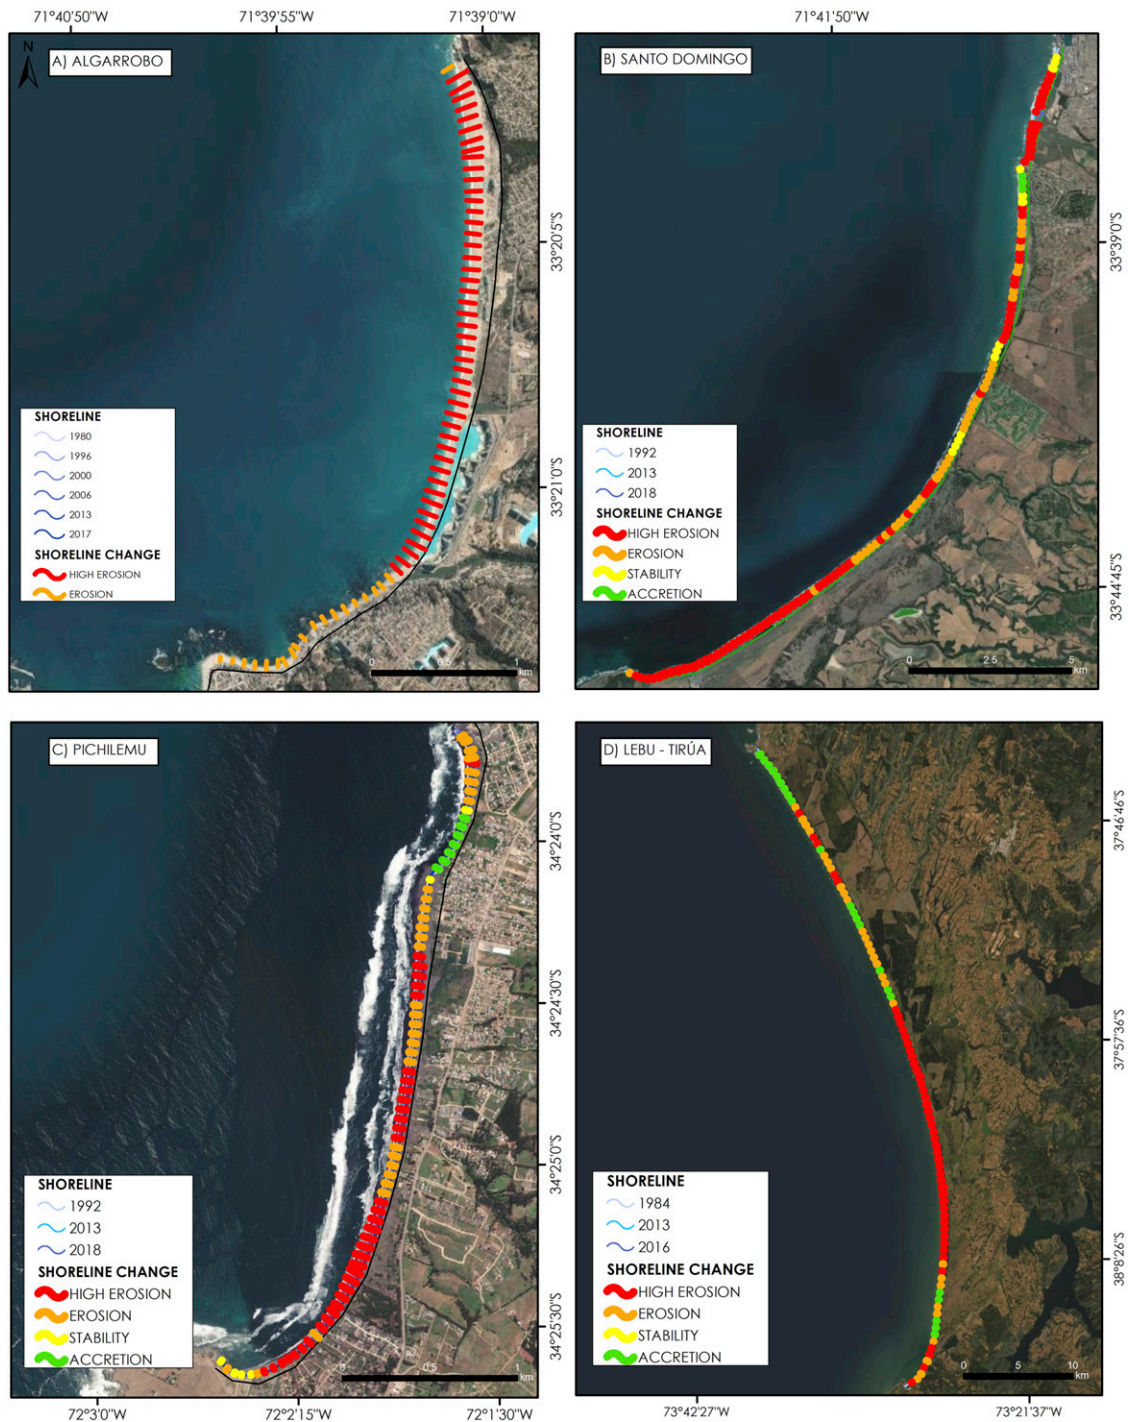
**Figure 5.** Spatio-temporal changes of the shoreline at headland bay beach in south-central Chile. For interpretation of the references to colours in this figure legend, refer to the online version of this article.

Figure 5 shows the annual shoreline rate of change classified in, for example, four headland bay beaches along north-central Chile (32°–33°S). The beaches of Algarrobo ( $-2.54$  m/yr between 1980 and 2017) and Santo Domingo ( $-1.73$  m/yr; 1992–2018) showed high erosion rates for the winter season according to Rangel-Buitrago et al. (2015) categories. Pichilemu ( $-1.3$  m/yr; 1992–2018) presented erosion rates for data covering both winter and part of spring. Lebu-Tirúa ( $-1.39$  m/yr; 2013–2016) also showed erosion rates for a relatively short period where data was available (may). Figure 6 depicts, in addition, three pocket beaches which erosion rates (between  $-0.2$  and  $-1.5$  m/yr) in north-central Chile (32°–33°S). Sandy shorelines in Cartagena bay and Tunquén beach revealed erosion rates of  $-0.61$  and  $-0.56$  m/yr,

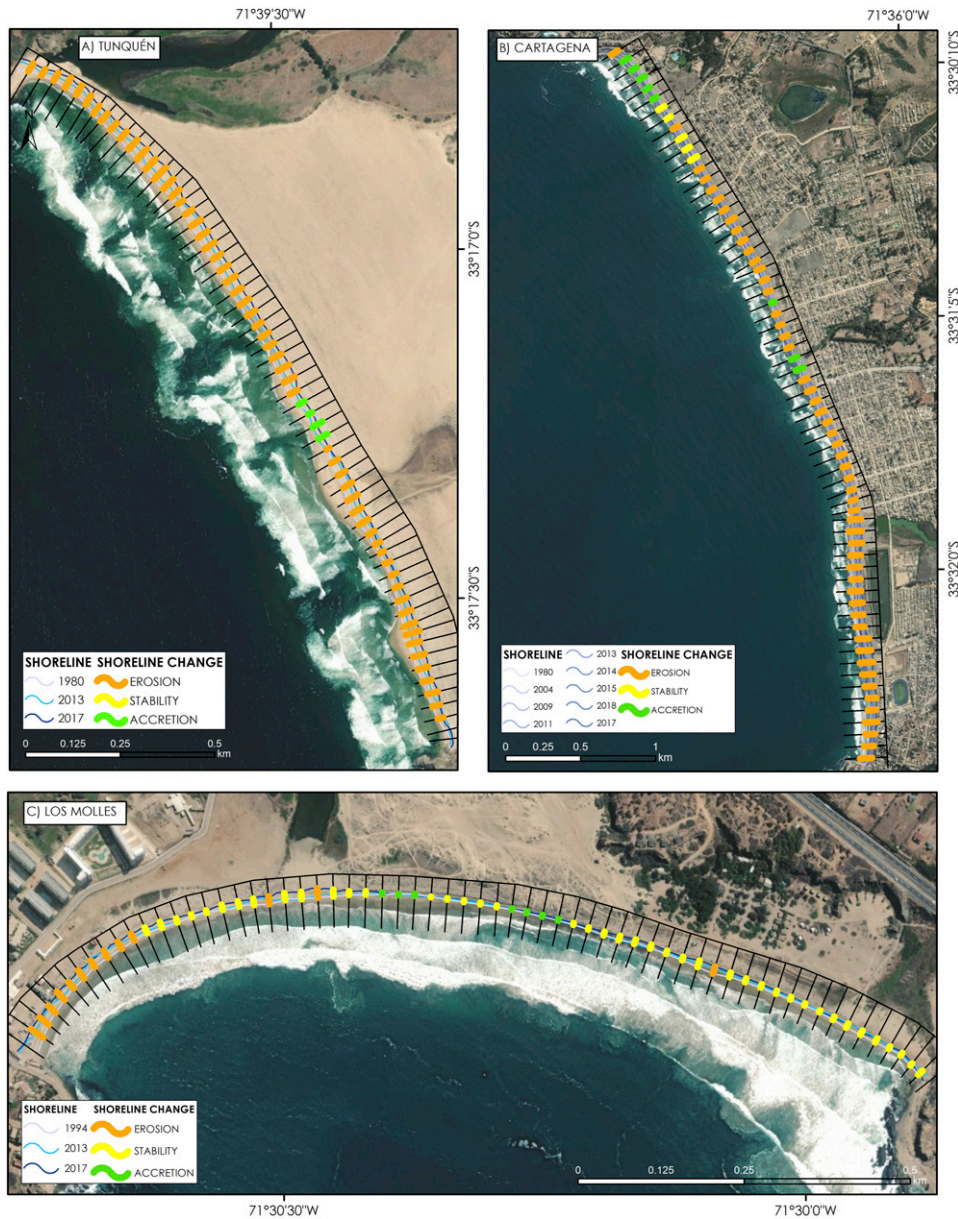
**Figure 6.** Spatio-temporal changes of the shoreline in the embayed beaches of central-northern Chile. For interpretation of the references to colours in this figure legend, refer to the online version of this article.

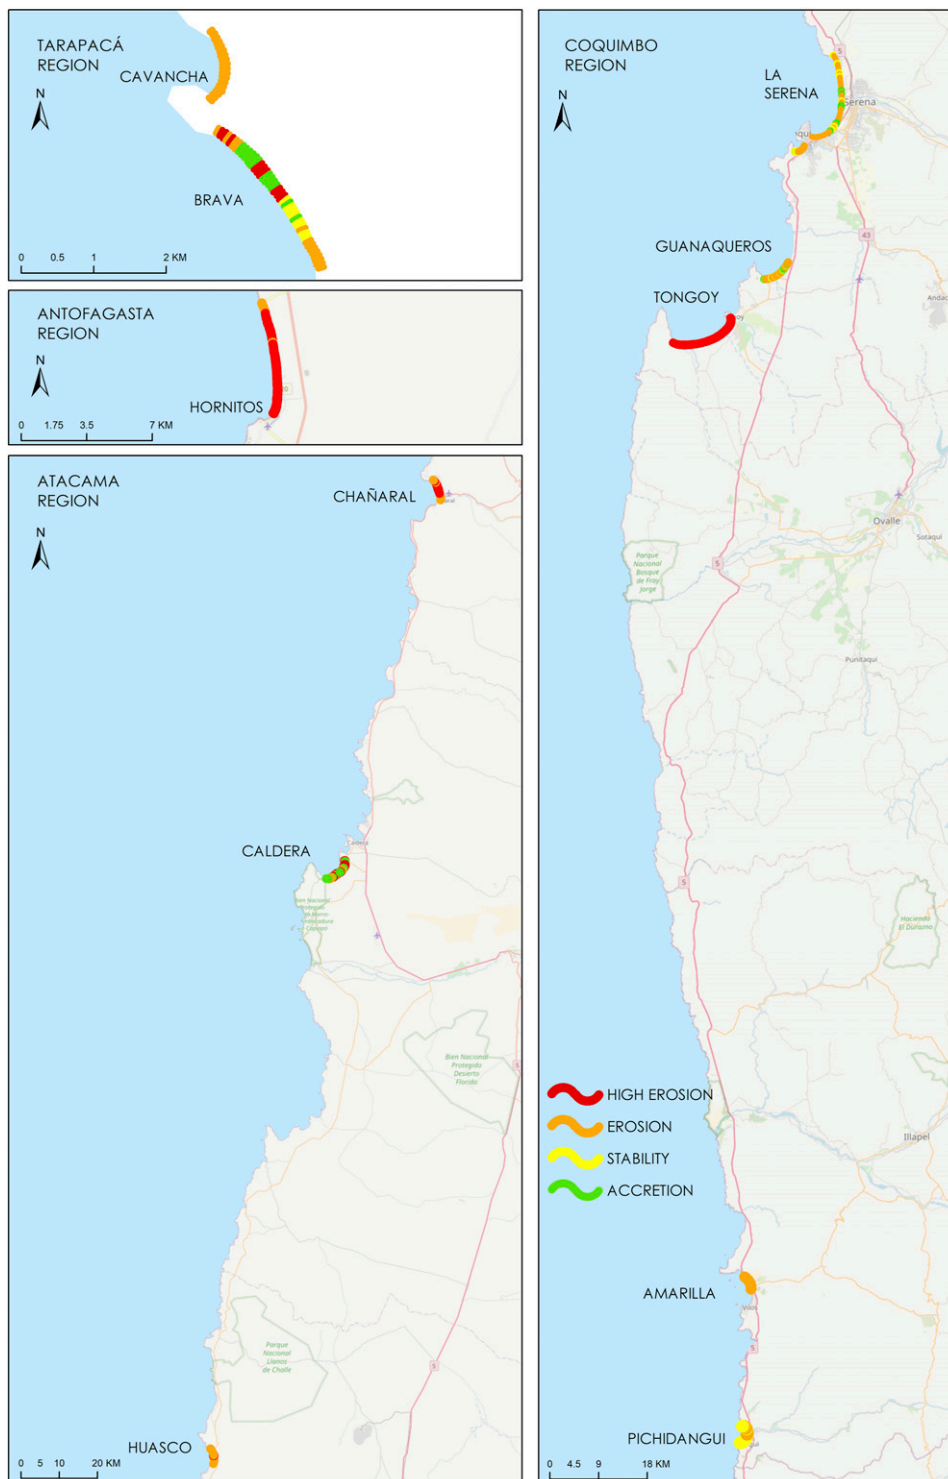
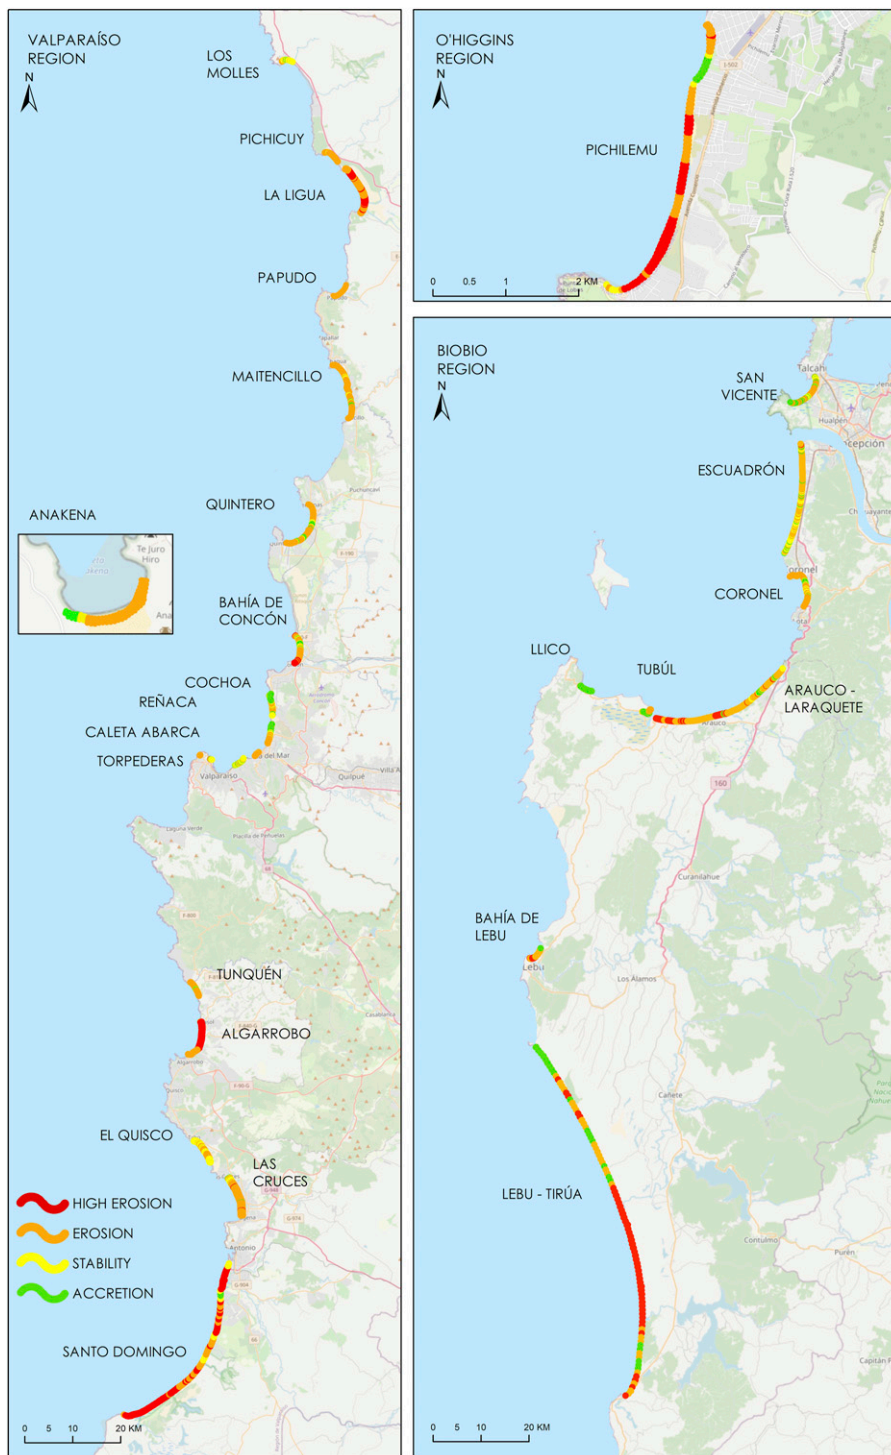
Figure 7. Continued.

**Figure 7.** Annual shoreline rate of change in all beaches, classified according to Rangel-Buitrago et al. (2015) categories: erosion in red ( $> -1.5$  m/yr), erosion in yellow (between  $-0.2$  and  $-1.5$  m/yr), stability in grey (between  $-0.2$  and  $+0.2$  m/yr) and accretion in green ( $> +0.2$  m/yr). Annual shoreline rate of change in all beaches, classified according to

Rangel-Buitrago et al. (2015) categories: erosion in red ( $>-1.5$  m/yr), erosion in yellow (between 0.2 and  $-1.5$  m/yr), stability in grey (between  $-0.2$  and  $+0.2$  m/yr) and accretion in green ( $>+0.2$  m/yr). For interpretation of the references to colours in this figure legend, refer to the online version of this article.

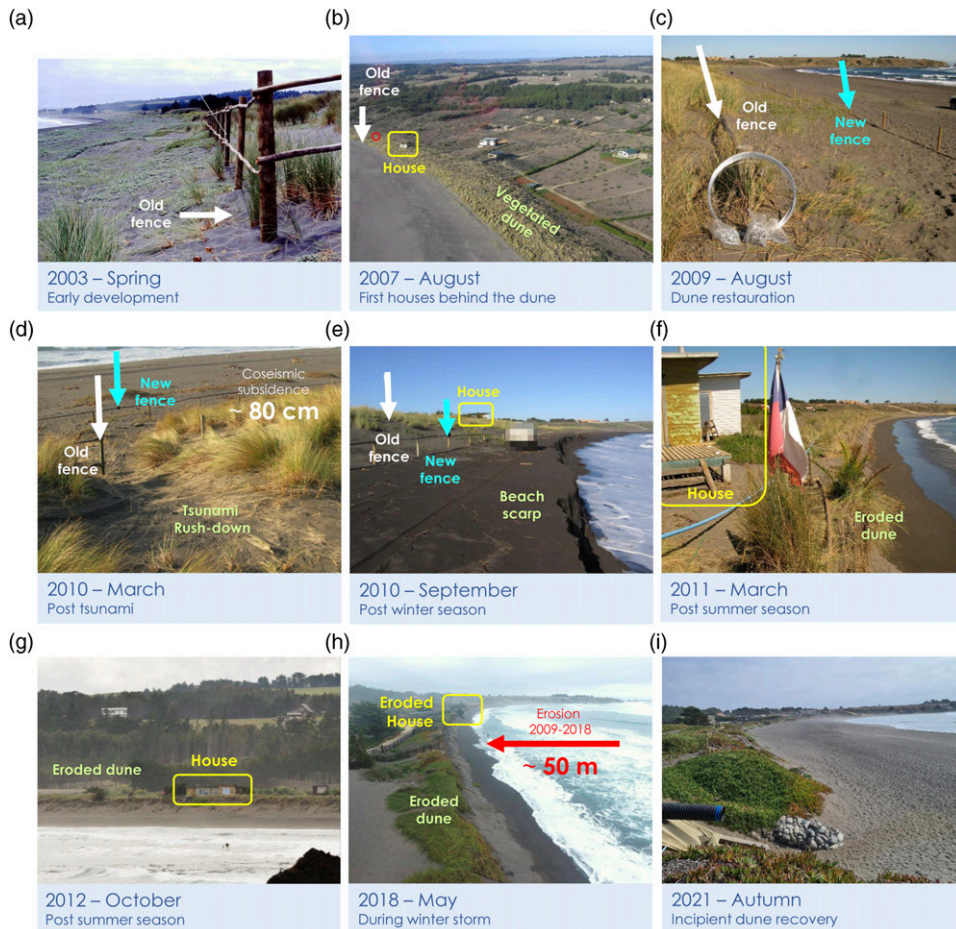
**Figure 8.** Series of photographs evidencing the significant shoreline recession following the 2010 Maule Earthquake in Pichilemu ( $34^{\circ}25'33.55''$ ,  $72^{\circ}2'15.09''$ ). Photographs' credits: (a) to (g) Nicolás Recordón. (i) Pablo Sanz. For interpretation of the references to colours in this figure legend, refer to the online version of this article.

The nearly 20-year evolution of Pichilemu (Figure 8) provides an interesting case of significant shoreline recession following the 2010 Maule Earthquake. In 2003, the beach was characterized by a wide backshore and dunes (a,b), the latter which were enhanced with plantation of *Ammophila arenaria* and access-control fences (c). The February 27th tsunami flooded the dune but caused no significant change in beach morphology. In the subsequent months, due to the significant coseismic subsidence, the dunes began to erode (e) until a house (f, g) was washed away. By 2012, the coastline had receded  $\sim 50$  m from its pre-earthquake position and remained relatively stable, with seasonal changes, until 2018 (h). In recent months, the backshore advanced (i) due to both natural processes and small-scale dune restoration projects. In contrast, Tubul and Lebu provide evident counter-examples of accreting beaches following the 2010 Maule Earthquake. As reported by Martínez et al. (2015) the width of these beaches was incremented by  $\sim 100$  m and a few tens of meters, respectively, as product and of a coastal uplift following the earthquake.
